NATIONAL TRANSPORTATION SAFETY BOARD

GROUP CHAIRMAN'S FACTUAL ADDENDUM CONCERNING RE-EXAMINATION OF FUEL PROBES

DCA-96-MA-070

Location : East Moriches, New York
Date : July 17, 1996
Time : 2031 Eastern Daylight Time
Airplane : Boeing 747-131, N93119
Operated as Trans World Airlines (TWA) Flight 800

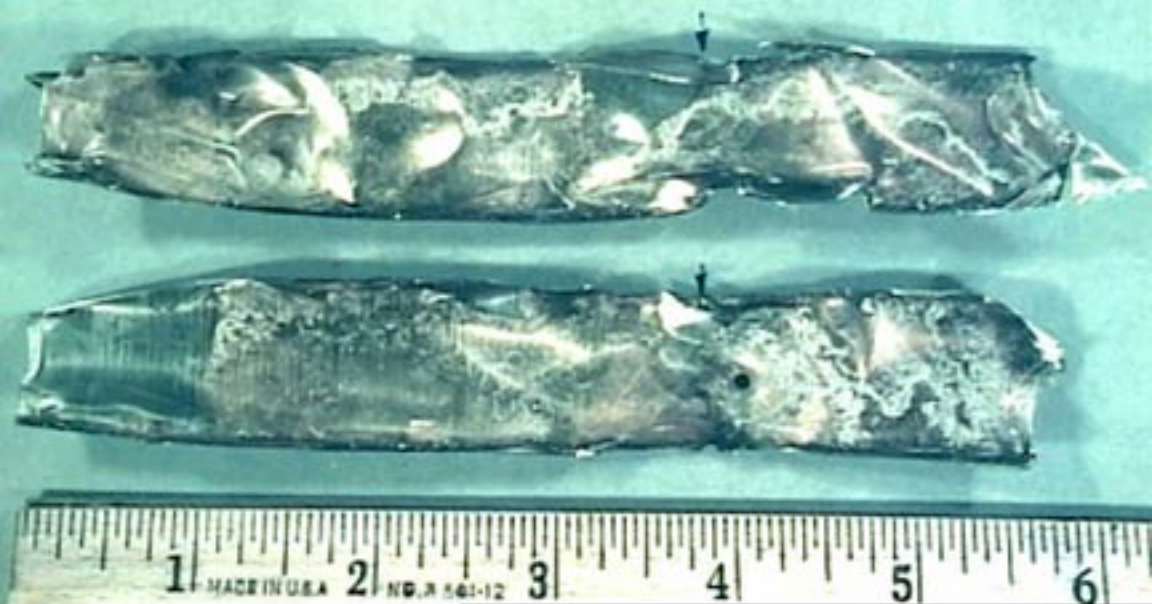
Photo 1. CWT aft-most fuel probe fragment (lower tip) interior. The arrows mark change in darkening. (No negative)

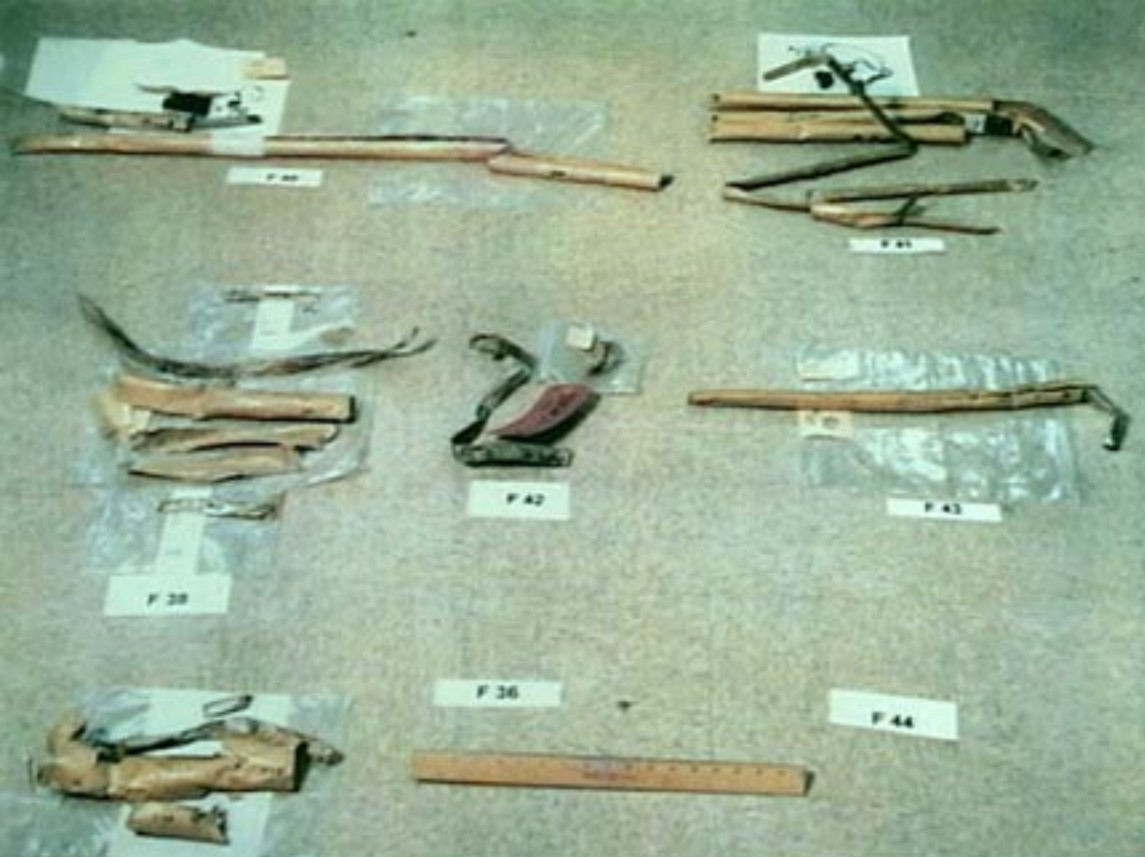
Photo 2. CWT fuel probe fragments, as laid out on May 1, 1998. (No negative)

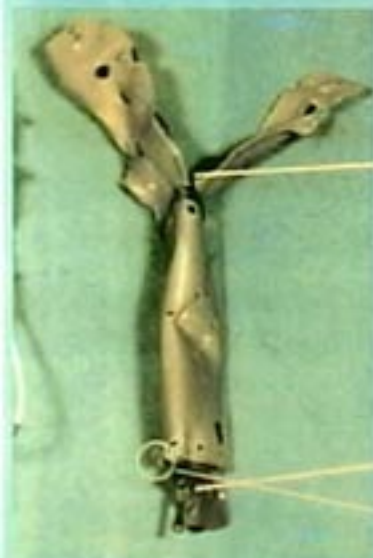
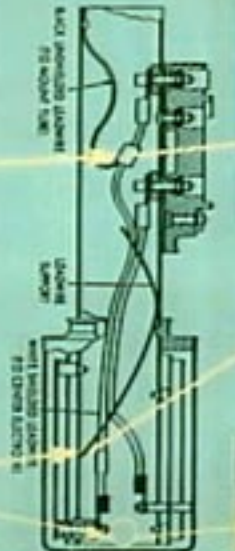
Features of Flattened FQIS Compensator

The Only Blackened/Sooted Metal was Found at the Bottom

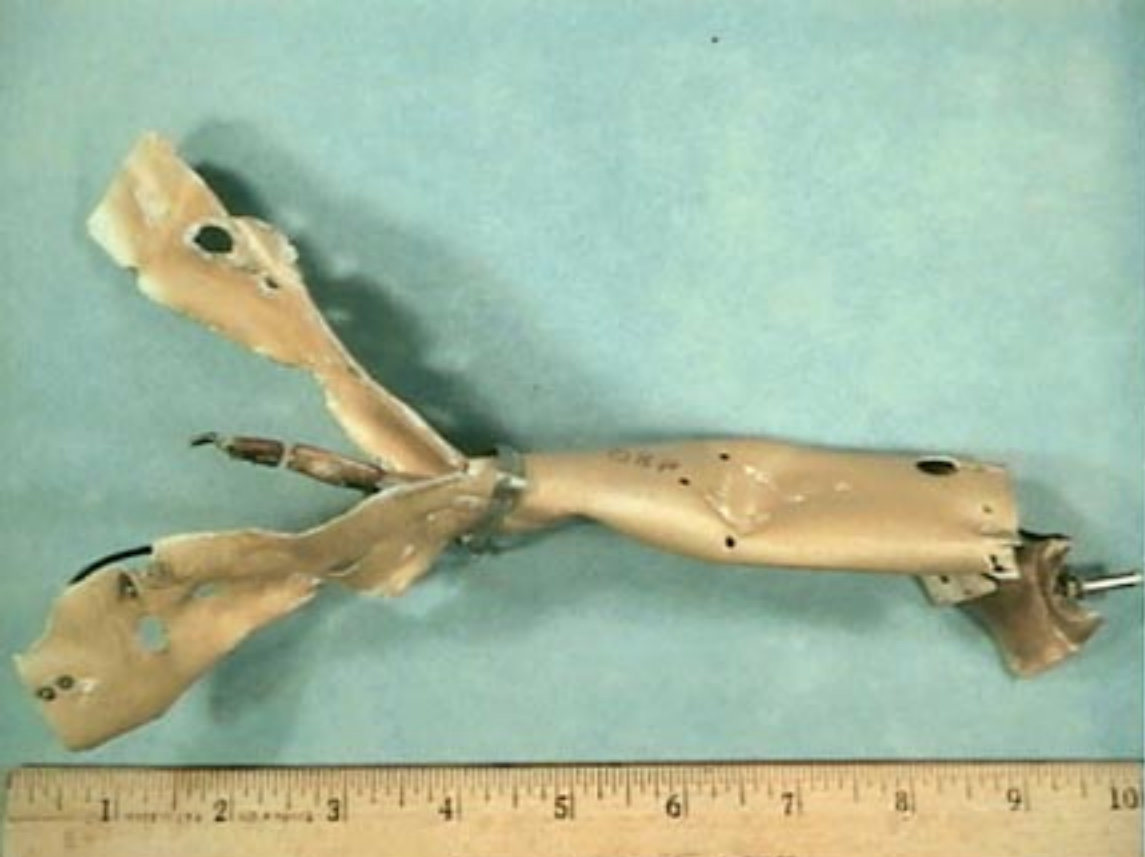
The location of the white Teflon insulator on the tube was marked with a red marker during the activity and the Teflon part was released by slipping off the band clamp. The upper third of the tube was then spread apart. The edges of the spread surfaces were the existing fractures in the tube. Two screws were found trapped in the collapsed portion of the tube. One internal screw was found with material missing from one side of the screw head. A protrusion of different shade and texture was seen under (75X) magnification in the missing area of the screw. The lower two thirds of the tube was split with small snips that did not create metal chips or dust. The cuts were minimized by cutting only to connect the existing splits and damage.

Photo 4. Fragment 80 Compensator after parting flattened upper third.

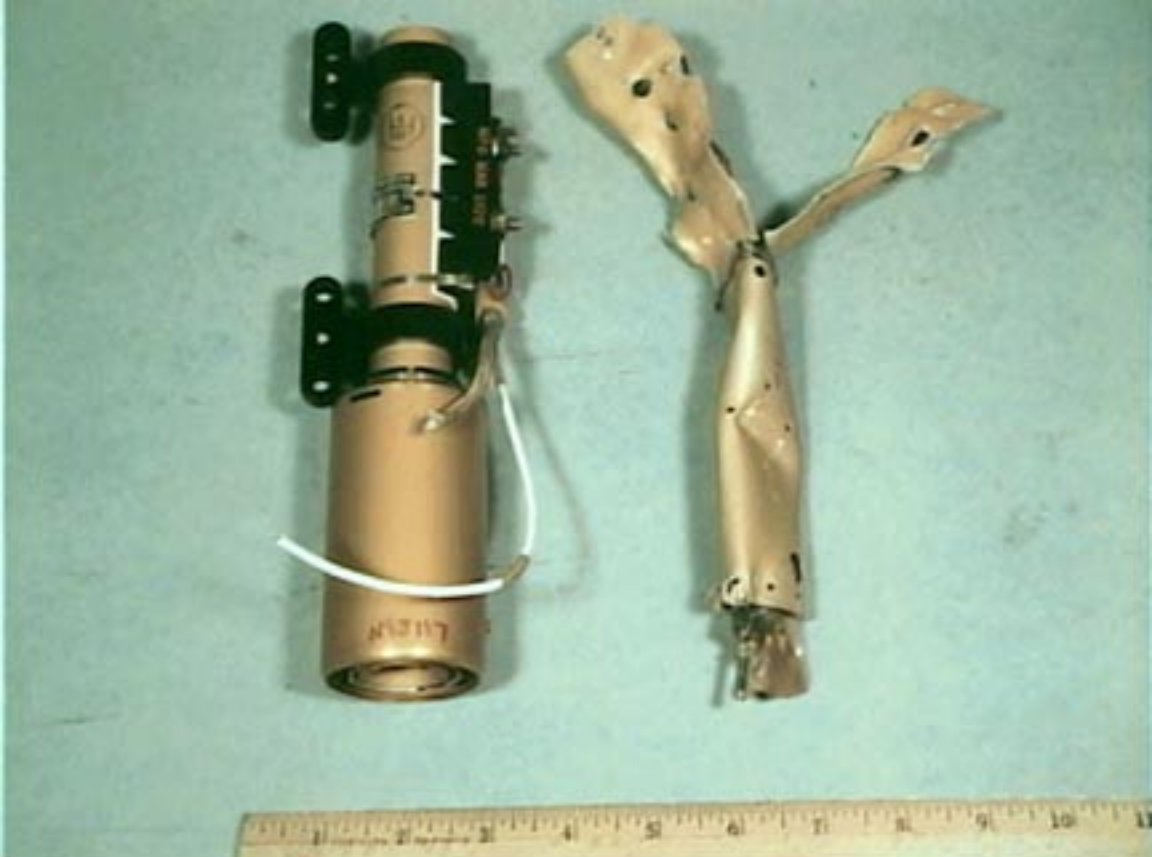
Systems 9 - Exhibit No. 9A - Addendum 1 - (Fuel Probes)
Photo 5. Fragment 80 Compensator on right. Similar part on left.

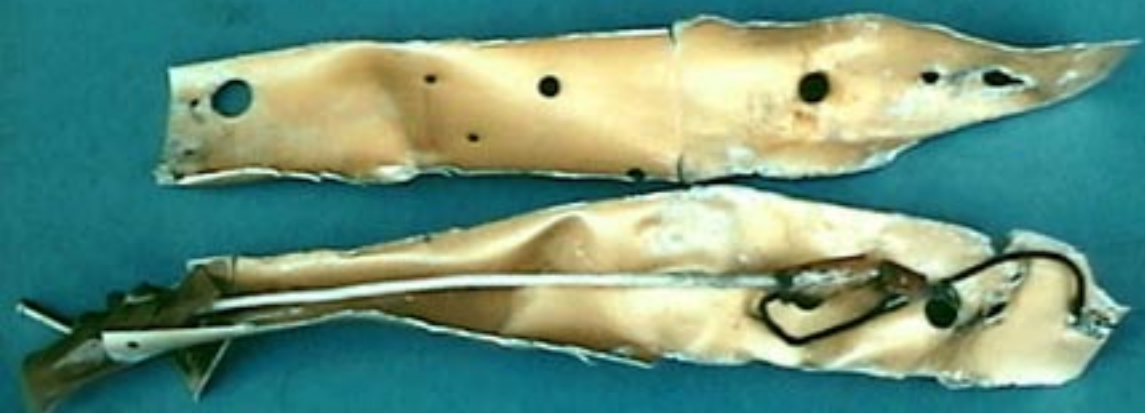
Once the flattened top of the support tube was opened, four plastic electrical parts inside were found blackened, pitted, and resolidified along the lower edges. The blackening had an upward flow pattern and was confined to the lowest edges of a plastic sleeve that covers a wire shielding connection, two plastic insulators on ring connectors, and the plastic leadwire support. The general features of each plastic part did not appear to have been molten and each part retained its color. The bottom of one of the tube halves had a soot accumulation, but this was in an enclosed area that did not have the scouring marks found on the external surfaces or smoothness of the inner surfaces.

Photo 6. Fragment 80 Compensator inner features.

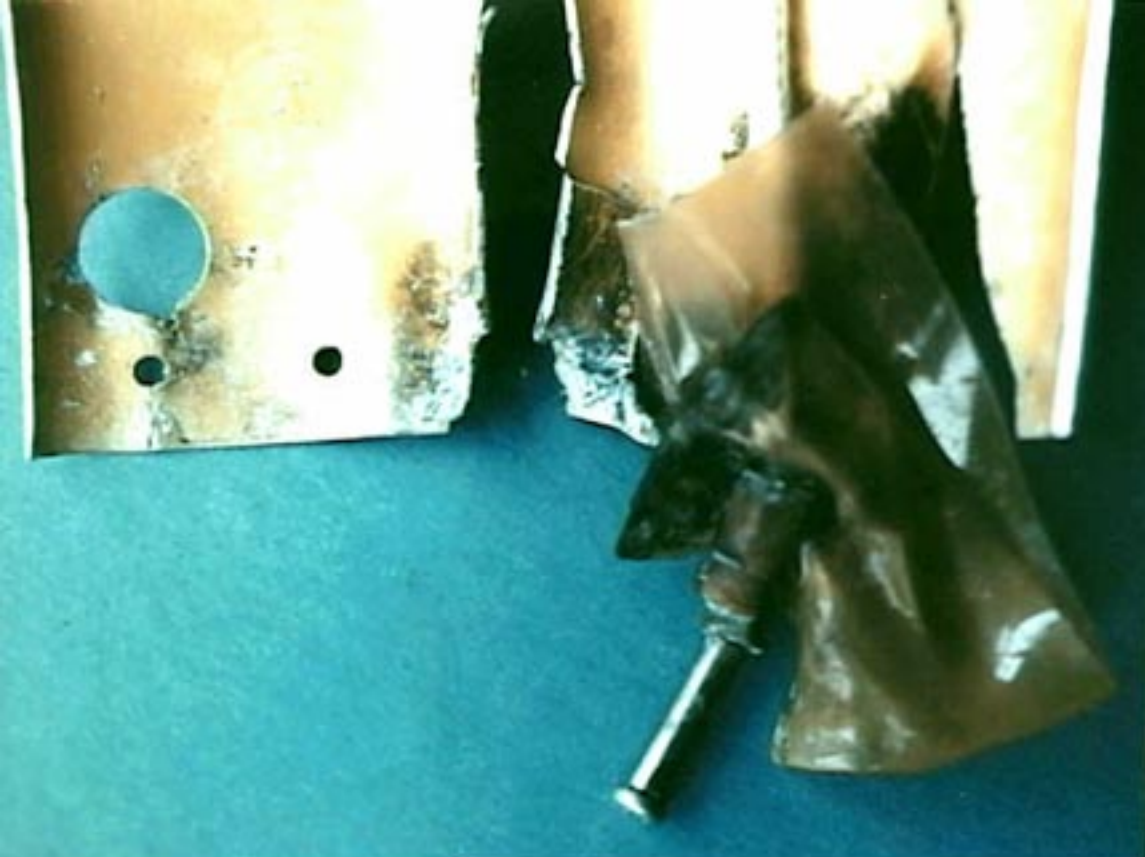
Photo 7. Fragment 80 Compensator inner features at bottom. Plastic wire support is folded; bottom is burned end.

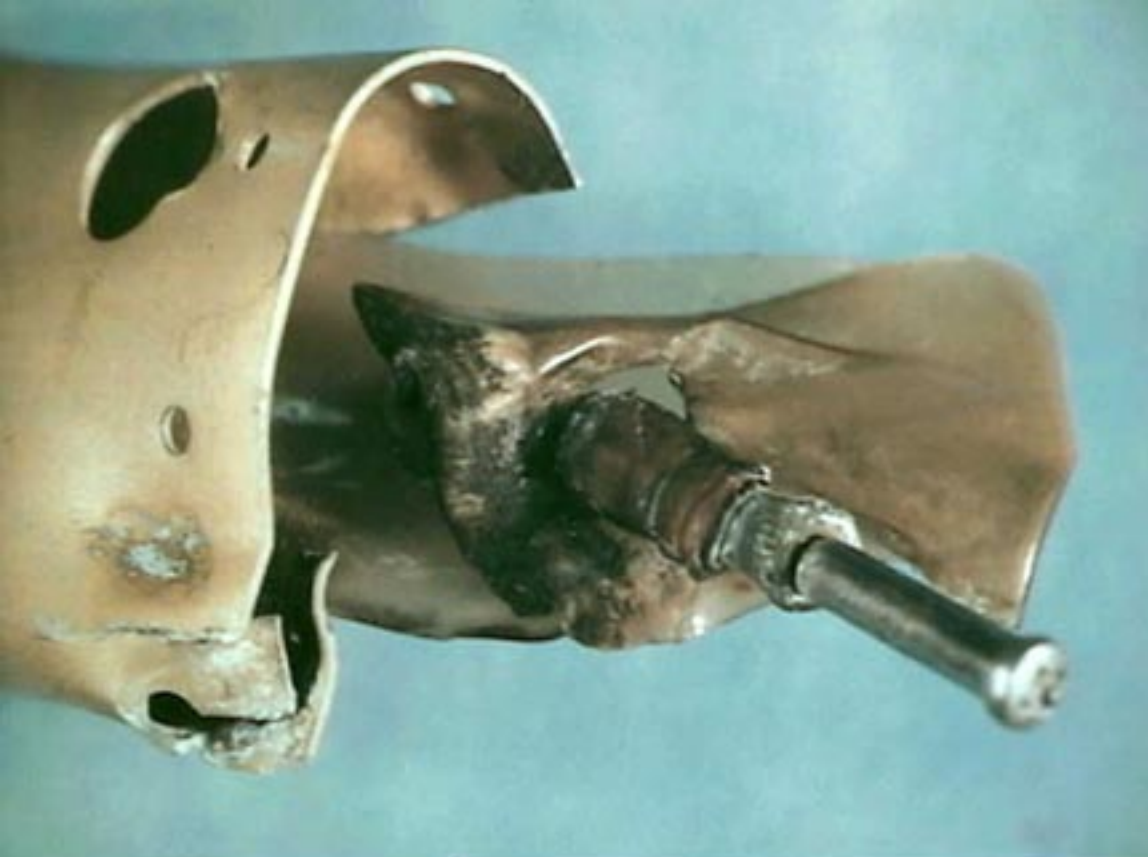
Photo 8. Fragment 80 Compensator inner features at bottom. Plastic wire support is folded; bottom is burned end.

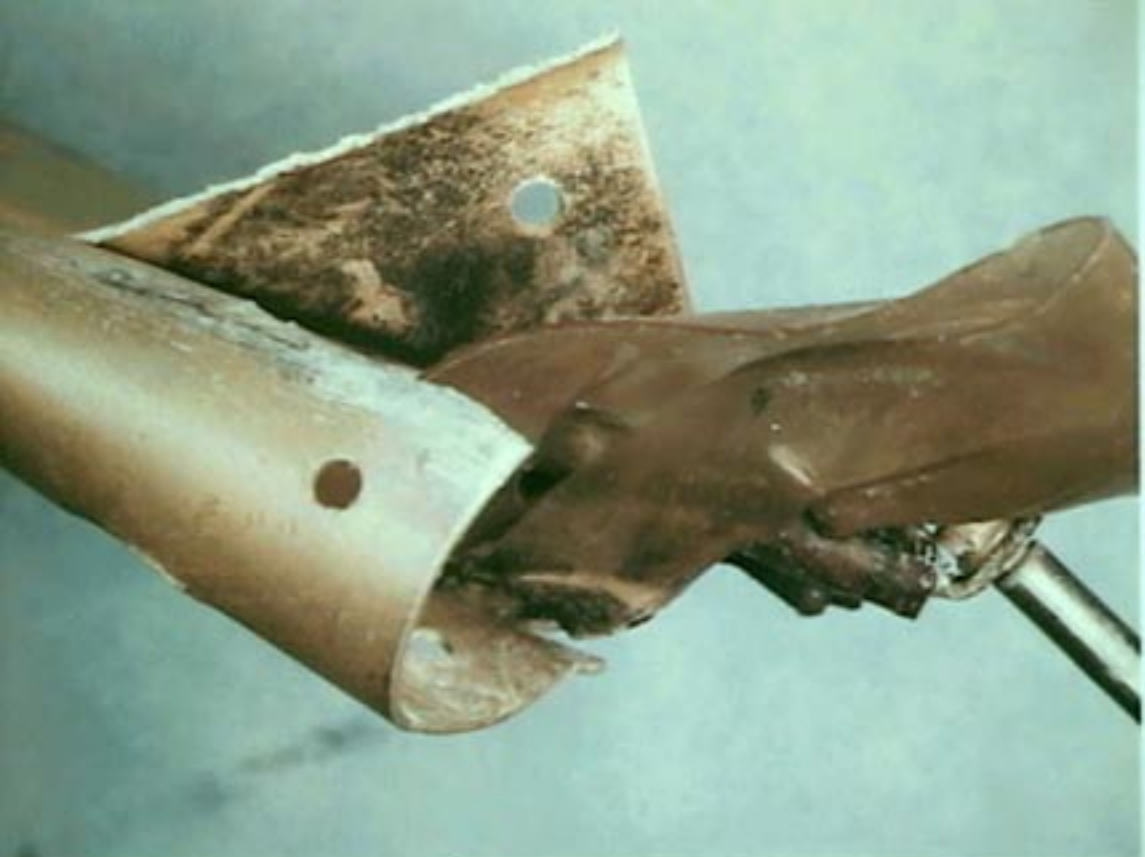
Photo 9. Fragment 80 Compensator inner features at bottom. Plastic wire support is folded; bottom is burned end.

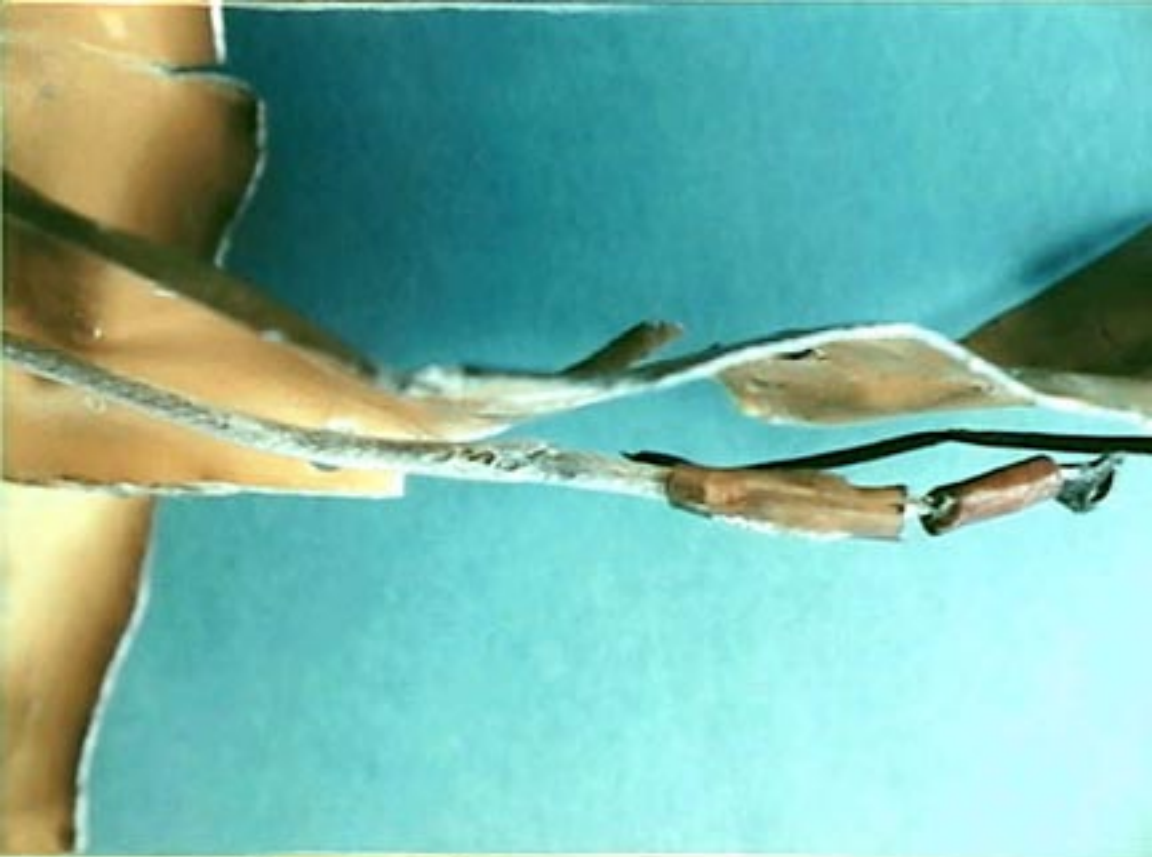
Photo 10. Fragment 80 internal HI-Z wire & upper ring connector with splice to shield ground (black wire). Darkened lower features of splice & red insulator are visible.

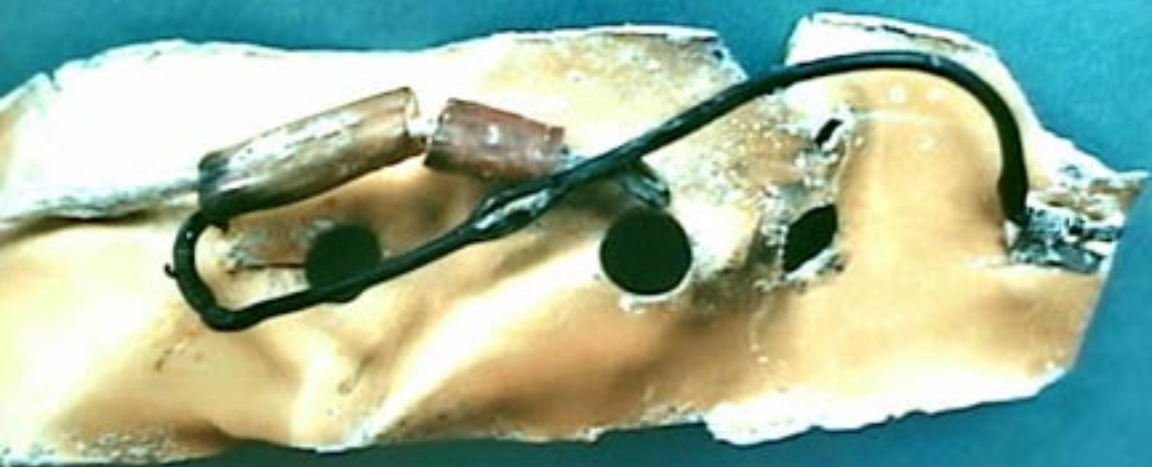
Photo 11. Fragment 80 internal HI-Z wire & upper ring connector with splice to shield ground (black wire). Darkened lower features of splice & red insulator are visible.

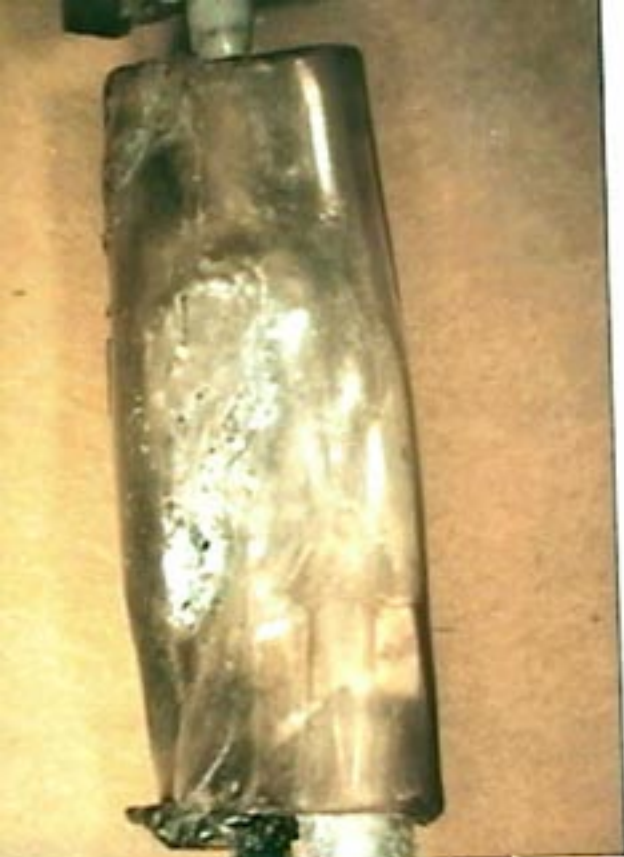
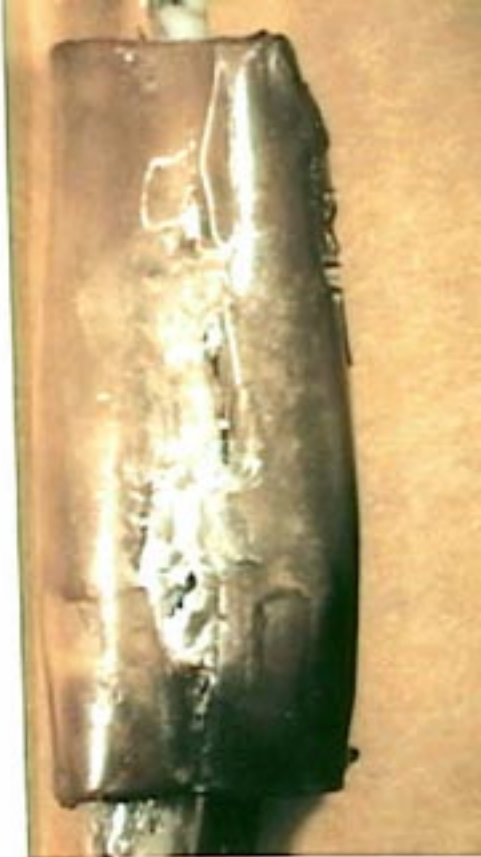
Photo 12. Fragment 80 Compensator internal HI-Z splice with blackened features at the bottom. Localized melting visible at bottom of left photo.

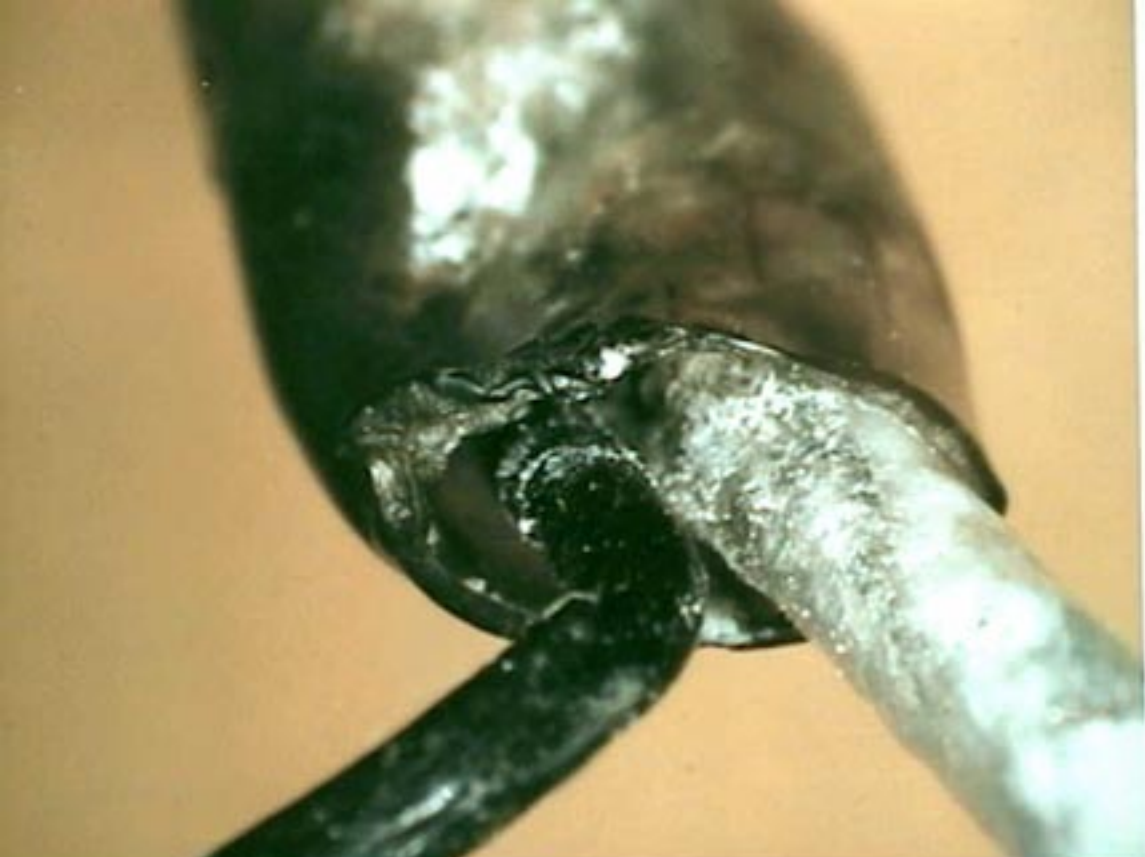
Photo 13. Fragment 80 Compensator interior. Bottom of HI-Z splice showing blackened plastic and deformation.

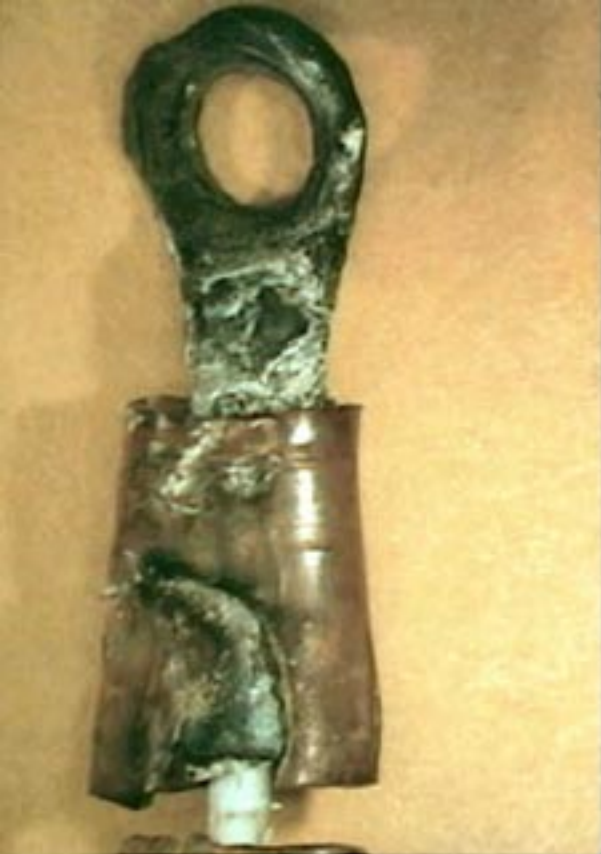
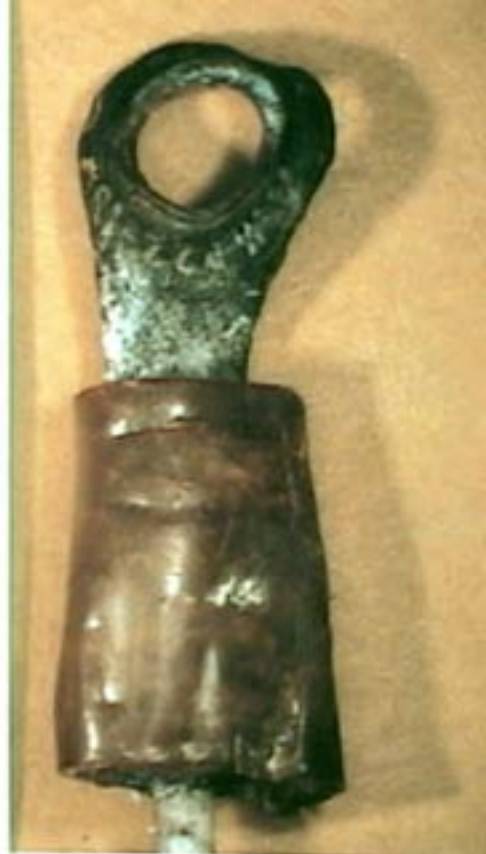
Photo 14. Fragment 80 Compensator internal upper HI-Z ring connector front and rear. Darkened plastic visible at bottom.

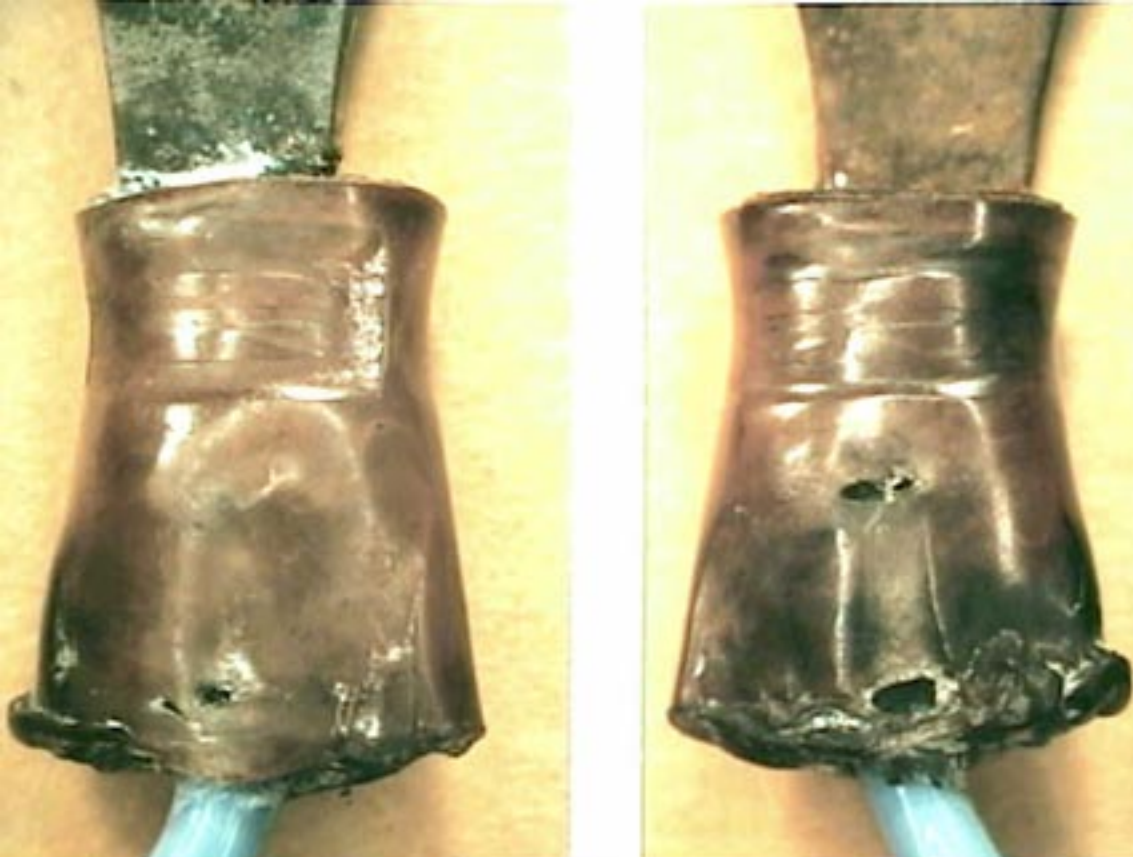
Photo 15. Fragment 80 Compensator internal upper LO-Z ring connector with blackened and deformed lower plastic features. Left photo faces head of screw.

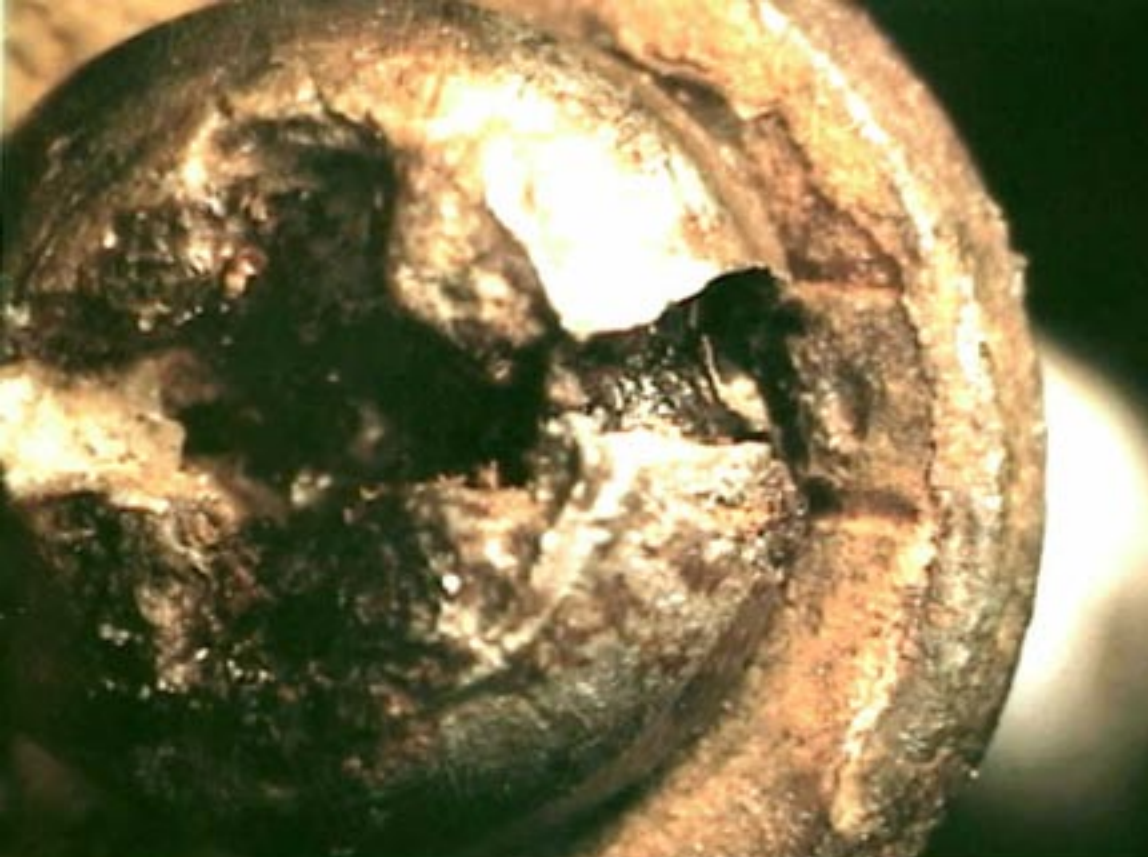
Photo 16. Fragment 80 Compensator upper LO-Z screw end ring with alignment of marks.

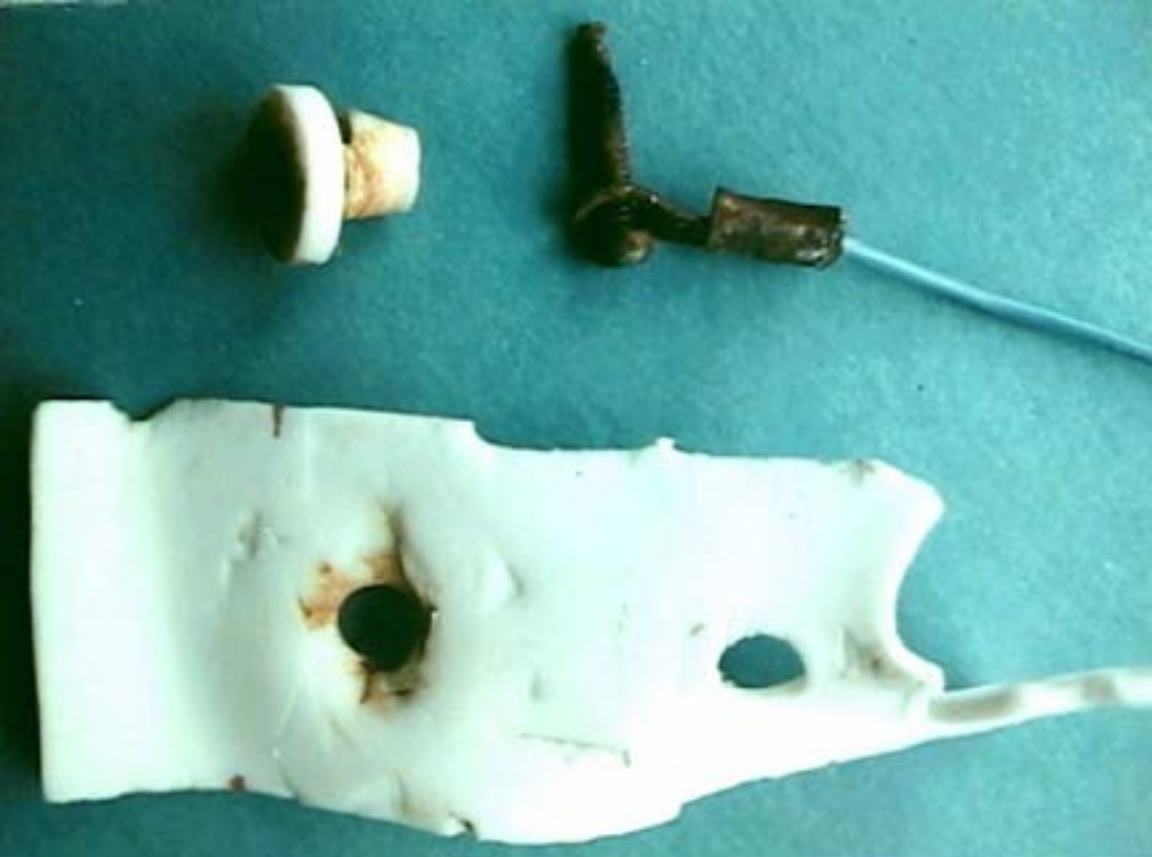
Although the terminal block is missing, the white Teflon insulator from beneath the terminal block remains attached to the support tube. A demarcation in the reflection of light from the anodized surface of the fragment aligned with the (outer electrode) top cover of a FG6C1 or C2 exemplar. The HI Z attachment machine screw sleeve (FG6C Overhaul Manual, Fig. 1101, item 38) from the lower end of the compensator has a diameter of .124 inches, corresponding to parts used in FG6C2 or FG6C4 Series 1, both of which use non-knurled “smooth” terminal blocks.

Photo 17. Fragment 80 Compensator terminal block teflon insulators, exterior (terminal block) face.

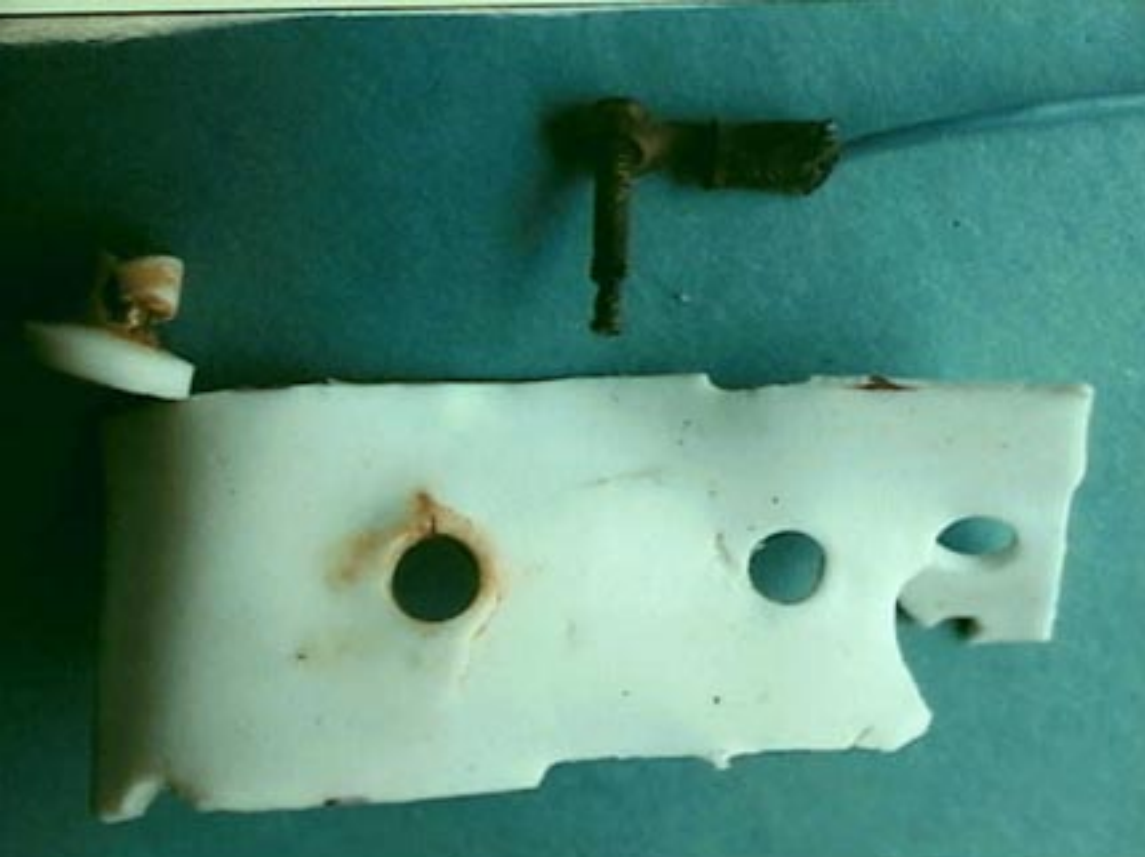
The only potential external evidence of blackening damage on the external surface was a small darkened flow pattern around a hole that was under the terminal block Teflon insulator. No other external evidence of soot or heat was found, including in the enclosed areas of folded aluminum where it had been bent, or under the Teflon insulator.

Photo 18. Fragment 80 Compensator terminal block teflon insulator, tube face.

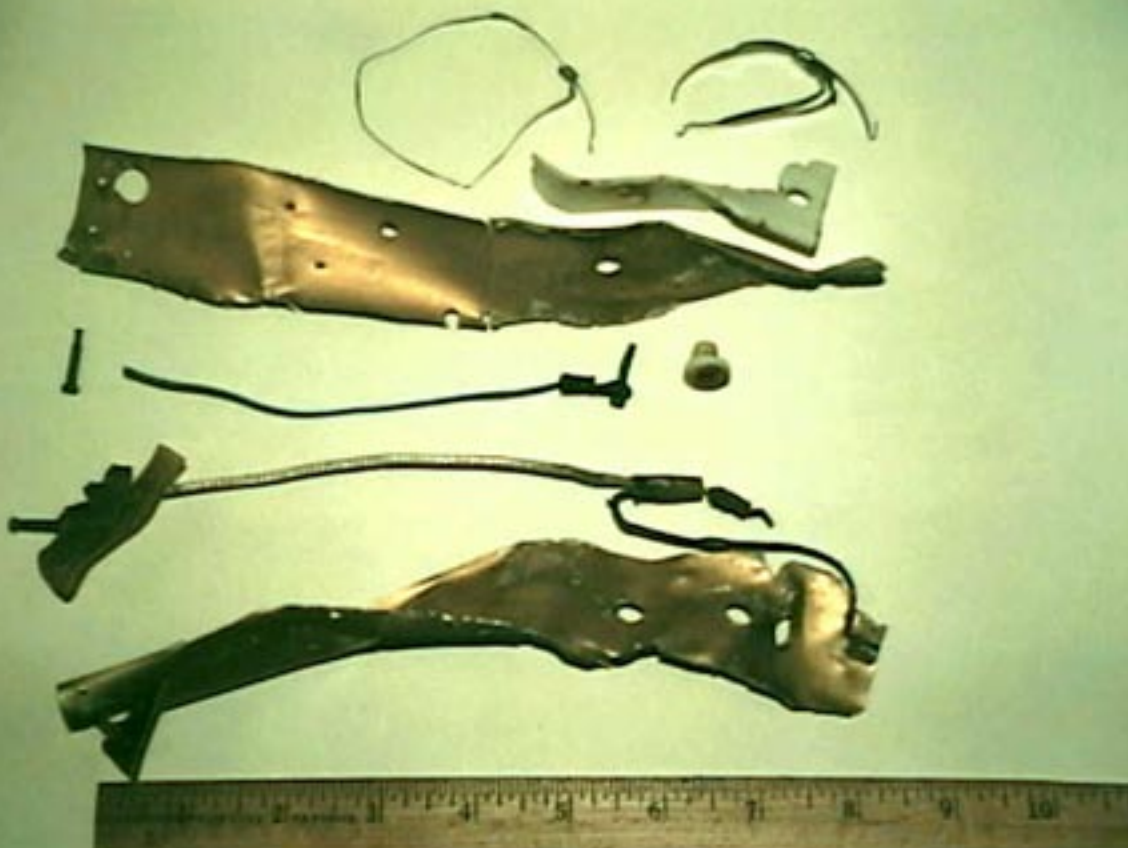
Photo 19. Fragment 80 Compensator parts. Ruler is to right of compensator.

Loose screw at left is misplaced and is upper HI-Z screw.
